Excess wear on equipment

Robert Kuenzi Consulting
Sonnhaldenstrasse 2
6373 Ennetbuergen, Switzerland

Is **frequent wear** at some specific locations a challenge?

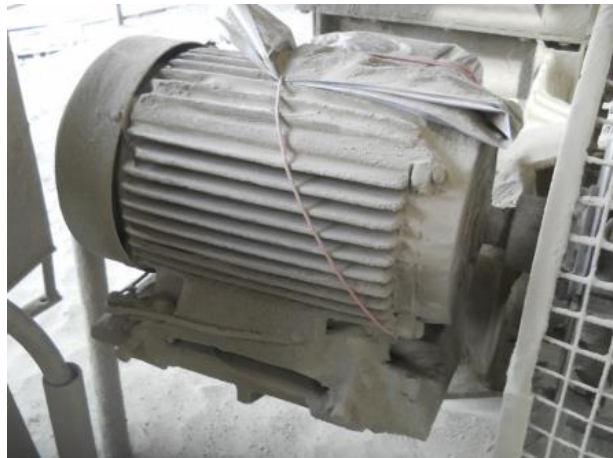
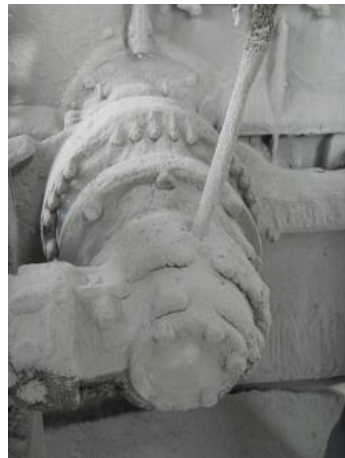
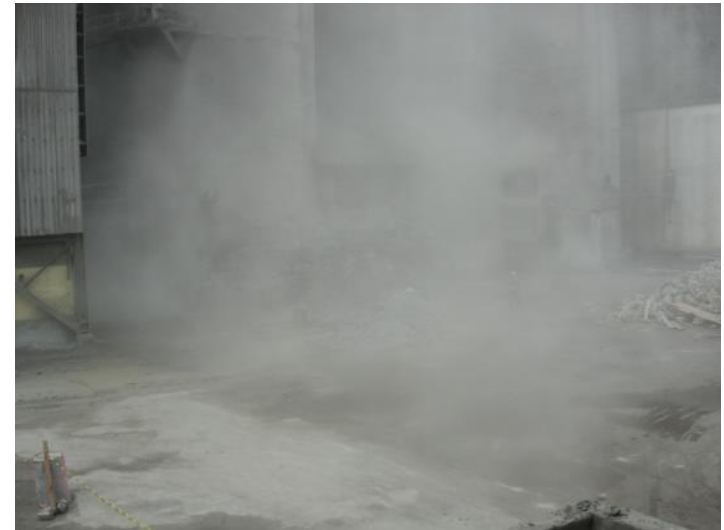
- This is causing high cleaning costs and wear at surrounding equipment.
