# Excess wear on equipment

# Is **frequent wear** at some specific locations a challenge?

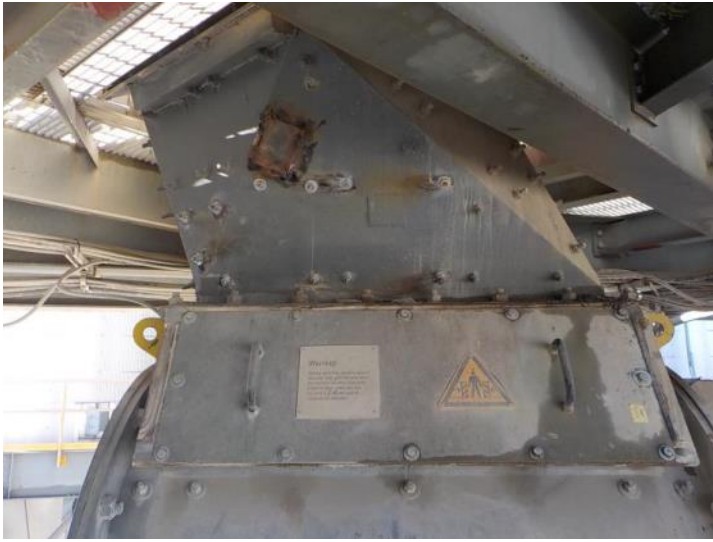
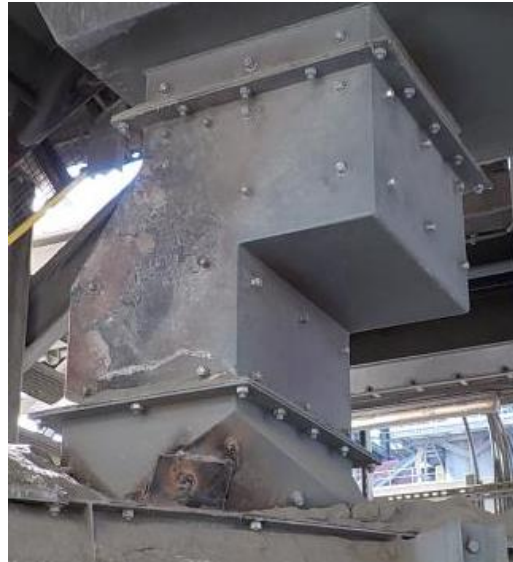
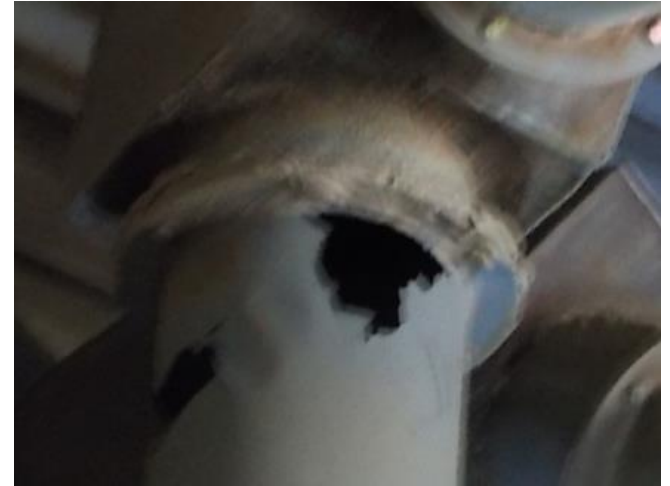
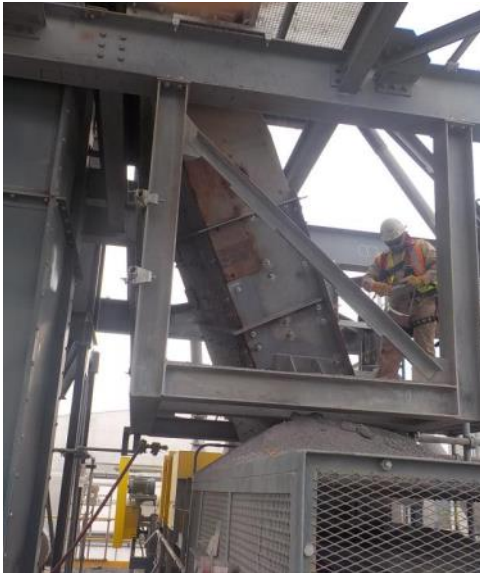
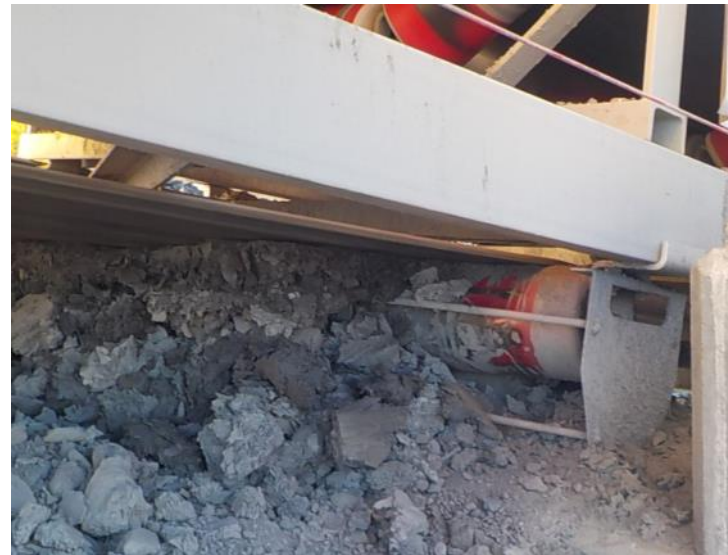
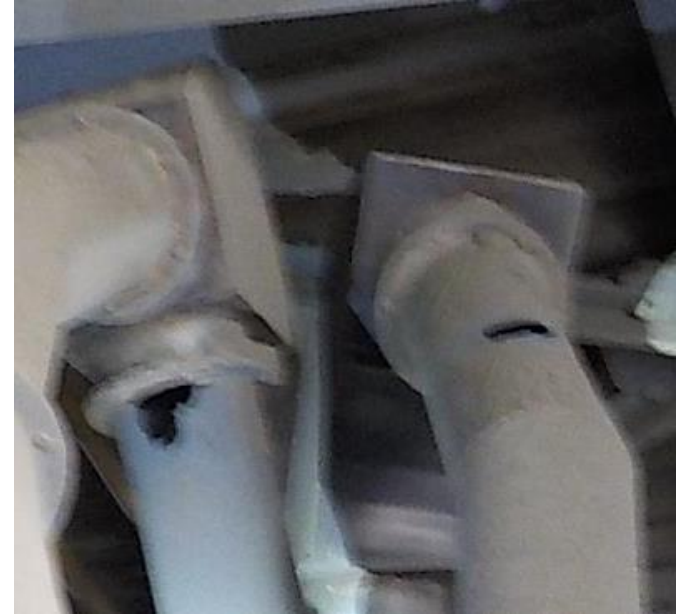
# Typical examples of frequent wear & consequences

- Conveyor discharge chutes.
- Vertical roller mill inlet chutes.
- Dedusting duct work.

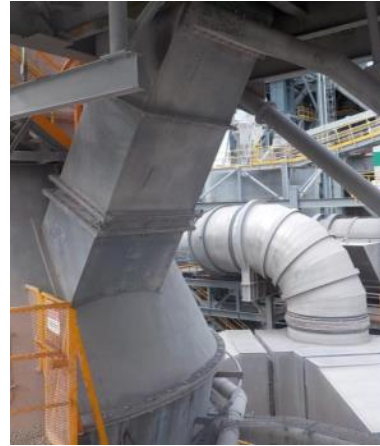
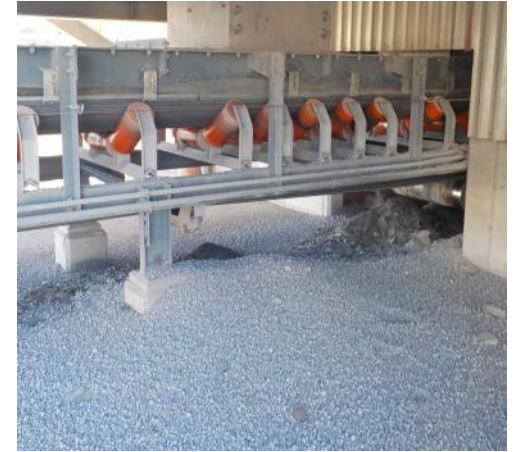
- This is causing high cleaning costs and wear at surrounding equipment.

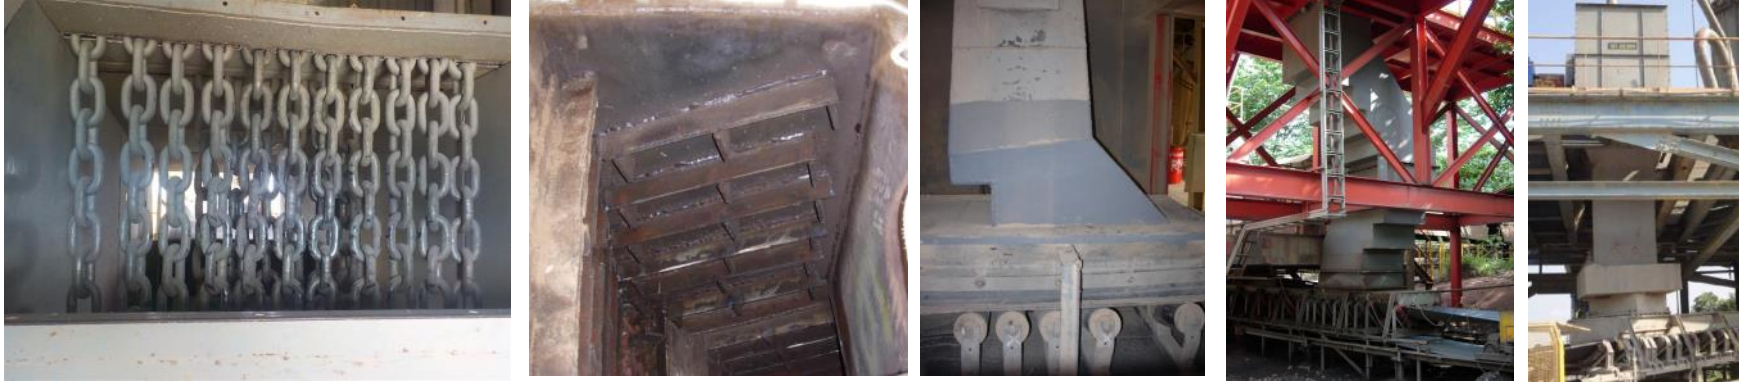
236 BC01: Feeding from BC4

- Problem
  - Unnecessary wear (and therewith spillage) at 236-BC4 feeding.
- Root cause
  - Design optimisations possible (for a dry material).
- Recommendation
  - Modify chute into a step chute design (horizontal step size ~180 mm)
